# Manhole Inspection Summary

Manhole # S41E\_\_035MH

Insp Date: **9/12/08 10:16 AM**

**Location** Address: **15 s caroline st**

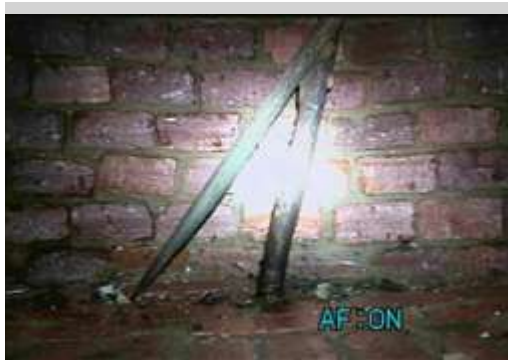
Defect 3

Condition: ☒ Sound ☐ Cracked ☐ Root Intrusion ☐ Deteriorated ☐ Leaks ☐ Debris

bench debris

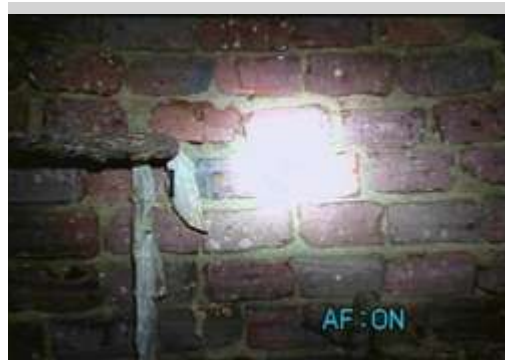
Defect 2

☒ **Evidence Of Surcharge** Depth: **3.** (ft.) ☐ Active Surcharge Present

surcharge evd

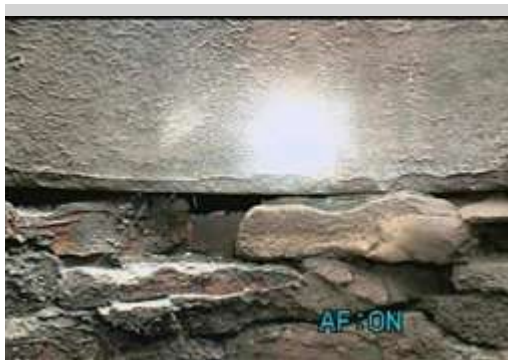
Defect 1

Condition: ☐ Sound ☐ Cracked ☐ Root Intrusion ☒ **Loose Brick** ☒ **Deteriorated**

chimney has loose brick, deteriorated

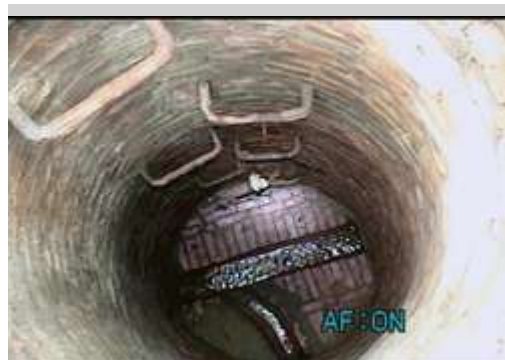
Count: **6** Missing: **0** ☒ **Corroded**

steps
